OFFICE OF THE INSPECTOR GENERAL

AIRCRAFT FUEL CELL PROCUREMENTS

Report No. 94-001

October 13, 1993

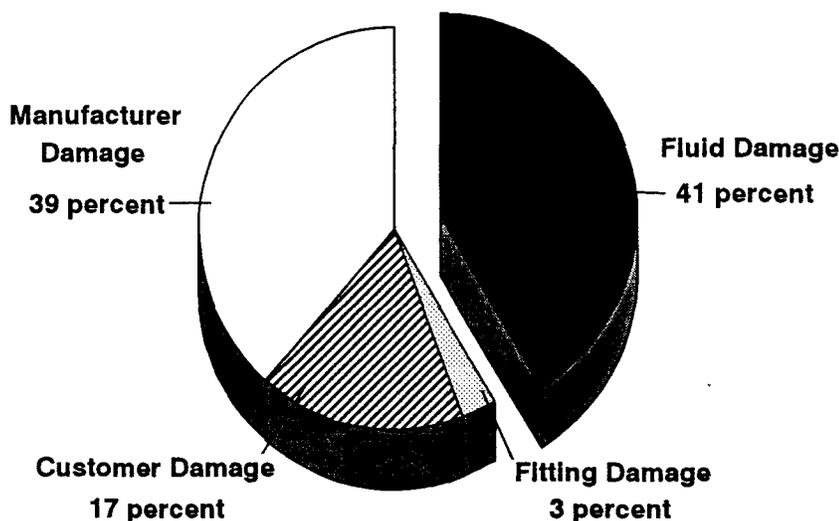
Figure 2. Quality Deficiencies Reported on AH-64 Helicopter Fuel Cells

Scope of AH-64 Helicopter Fuel Cell Problem. We took additional steps to determine whether Army users reported the outside delamination problem and whether ATCOM took any corrective action to prevent recurrence. We reviewed a total of 70 QDRs submitted to ATCOM on AH-64 helicopter fuel cell failures between 1986 and 1992. Of the 70 QDRs, 29 (41 percent) of the QDRs were for outside delaminations. An analysis of the QDRs and causes listed for premature failures of the AH-64 helicopter fuel cells is shown in Figure 2.

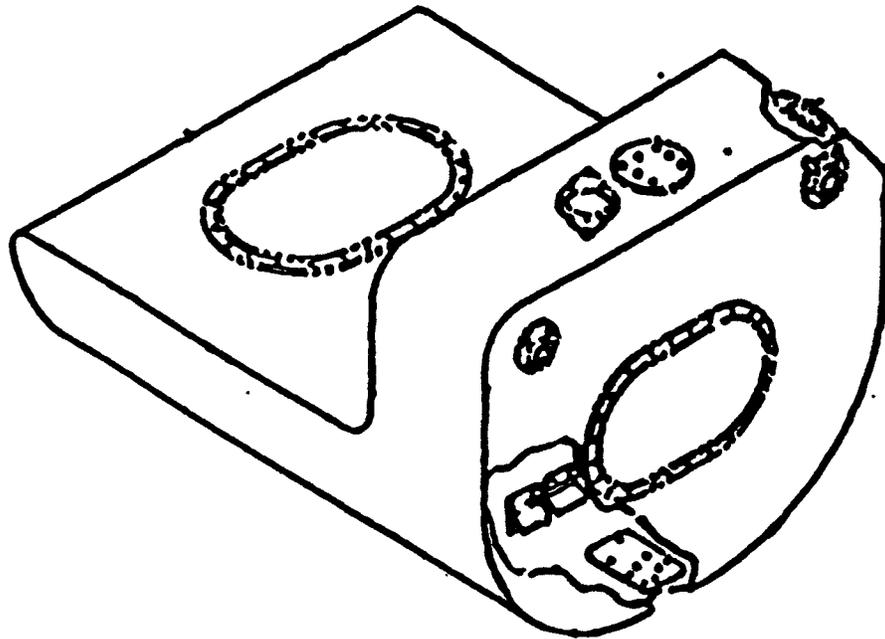
Figure 3. AH-64 Helicopter Forward Fuel Cell

Review of 146 fuel cells located at 4 Army sites showed that 42 were damaged because of improper storage and handling (Appendixes C and E). Of the 146 fuel cells, 21 were damaged beyond repair. The most significant problem occurred at Letterkenny Army Depot with the AH-64 helicopter forward fuel cell. The forward fuel cell collapses more easily because of its "L" shape, as seen in Figure 3. Fifteen of the forward fuel cells at Letterkenny Army Depot collapsed in their shipping containers and could not be straightened out. When the cells remain collapsed over a period of time, the self-sealing material migrates away from the creases in the fuel cell wall, leaving no self-sealing ability in the area and causing separation between plies.
