Ballistic Testing for Interceptor Body Armor Inserts
Needs Improvement

August 1, 2011

SUBJECT: Ballistic Testing for Interceptor Body Armor Inserts Needs Improvement
(Report No. D-2011-088)

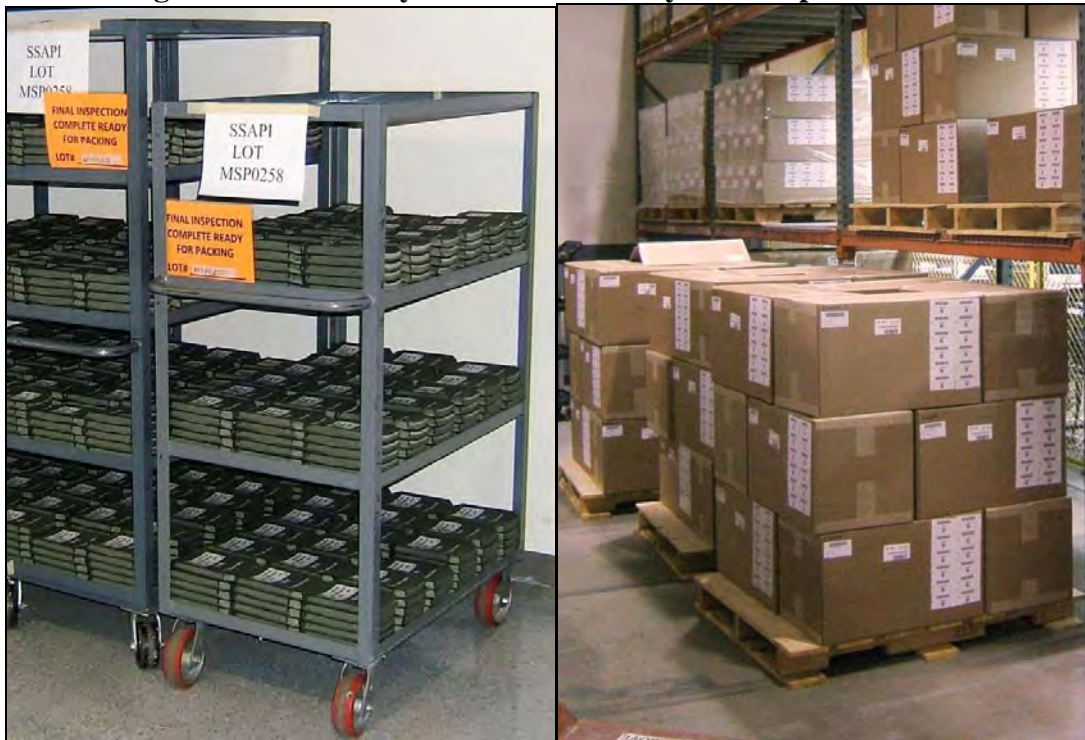
Figure 3. Hard Body Armor Lots Ready for Sample Selection

The QAR selects the samples and observes as a contractor employee verifies that weight and dimensions comply with contract requirements. The contractor employee records the serial numbers on the DD 1222, "Request for and Result of Tests," and the QAR signs it. The QAR then sends the samples and the DD 1222 to the applicable test lab for LATs.

DCMA Phoenix QARs did not use an appropriate sample selection process for selecting of ballistic inserts, and their method did not ensure that all items in the lot had the same probability of being selected for testing. This negated the sample test results and diminished the possibility the test labs would identify defects during LATs. In April 2010, we interviewed two QARs responsible for overseeing the BAE Systems and ArmorWorks contracts to identify the sampling methodology used to select ballistic inserts for LATs.
