# Inspector General

SUBJECT: Review of Electrocution Deaths in Iraq: Part II – Seventeen Incidents Apart  
From Staff Sergeant Ryan D. Maseth, U.S. Army (Report No. IPO2009E001)

## **Review of Electrocution Deaths in Iraq: Part II – Seventeen Incidents Apart from Staff Sergeant Ryan D. Maseth, U.S. Army**

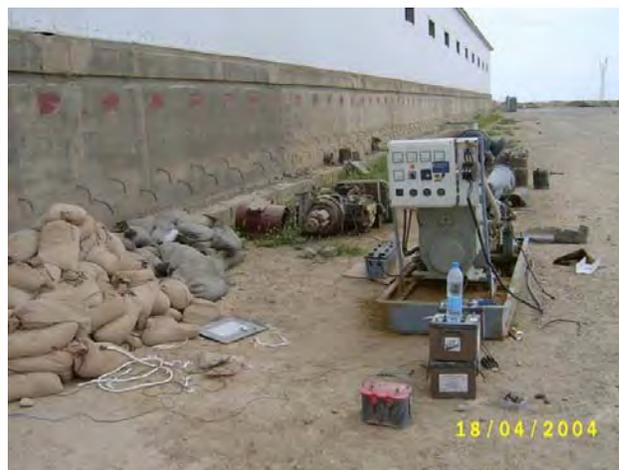
Specialist Marvin A. Campo-Siles was electrocuted while attempting a generator repair at Pad 9, Forward Operating Base Brassfield-Mora, Samarra, Iraq, on April 17, 2004. The generator and exterior of the housing unit involved in the incident are shown in the figure below.

**Figure 1. Generator and Housing Area  
Involved in the Specialist Campo-Siles Electrocution  
(From Army Photographs)**

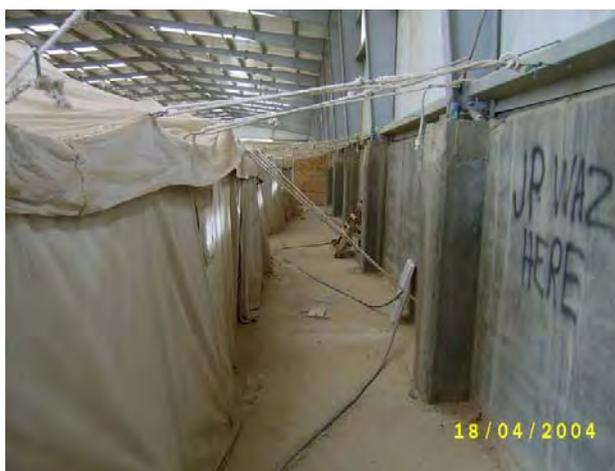
Specialist Campo-Siles was a trained and experienced generator repairman. On April 17, 2004, he and two other soldiers were performing maintenance on a generator supplying electrical power to two warehouse-like structures that housed U.S. soldiers on Forward Operating Base Brassfield -Mora. The generator was functioning, but the housing units were not receiving electrical power. The team checked voltage at the breaker box and concluded that electricity was not flowing through the breaker box. While Specialist Campo-Siles remained at the breaker box, the two other soldiers began following the wires to determine where the electrical “drop off” was occurring. The wiring from the generator (located outside the housing unit) and the interior of the housing area are shown in the figure below.

**Figure 2. Generator Cable and Housing Unit Involved in Specialist Campo-Siles Electrocution (From Army Photographs)**

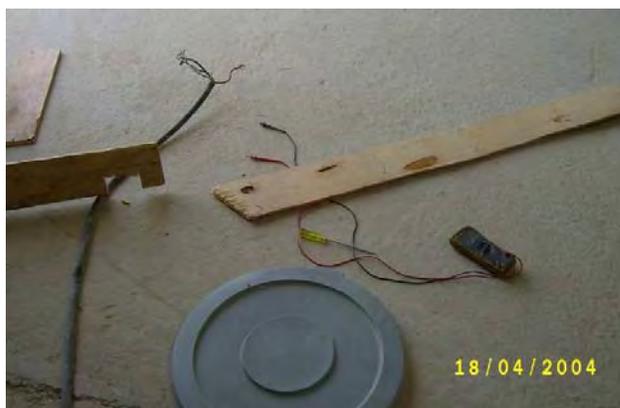
Shortly after leaving Specialist Campo-Siles, the two other soldiers heard a scream and, upon checking, discovered Specialist Campo-Siles lying on the ground. He apparently had disconnected wires from the breaker box and was holding live electrical wires in his hands. A yellow screwdriver apparently used for the disconnections was found near the electric meter. The incident site is shown in the figure below.

**Figure 3. Site Where Specialist Campo-Siles was Electrocuted (From Army Photographs)**

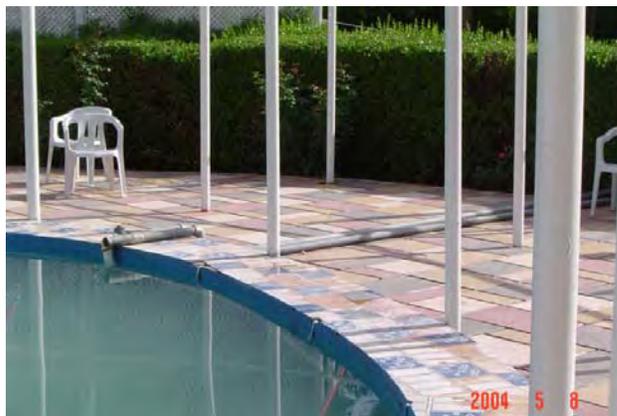
Specialist Chase R. Whitham was electrocuted while swimming in an outdoor pool at Forward Operating Base Patriot, Mosul, Iraq, on May 8, 2004. The site is shown in the figure below.

**Figure 4. Pool Where Specialist Whitham was Electrocuted (From Navy Photographs)**

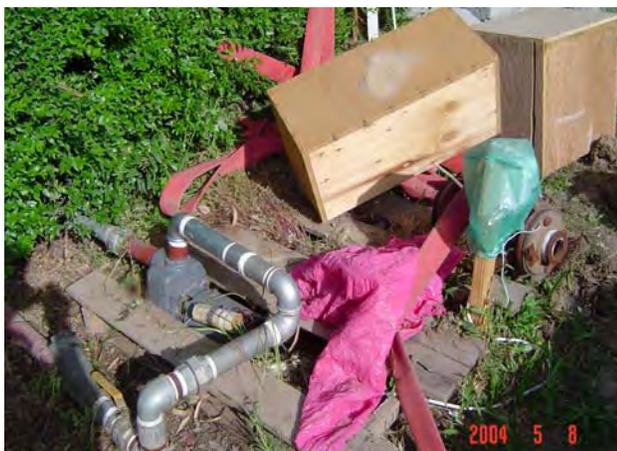
- **Water Pump:** The pump was located above ground, adjacent to a fuse box, and connected a water supply pipe, which continued to the pool, to a second above ground pipe, which also continued to the pool. The pipes were both 3-inch diameter metal pipes that extended about 20 feet through a hedge to the North swimming pool West side. Report of investigation photographs indicate boxes made of wood/lumber covered the pump and fuse box, as shown in the figure below.

**Figure 5. Covers for Pump and Fuse Box  
in Area Where Specialist Whitham was Electrocuted  
(From Navy Photographs)**

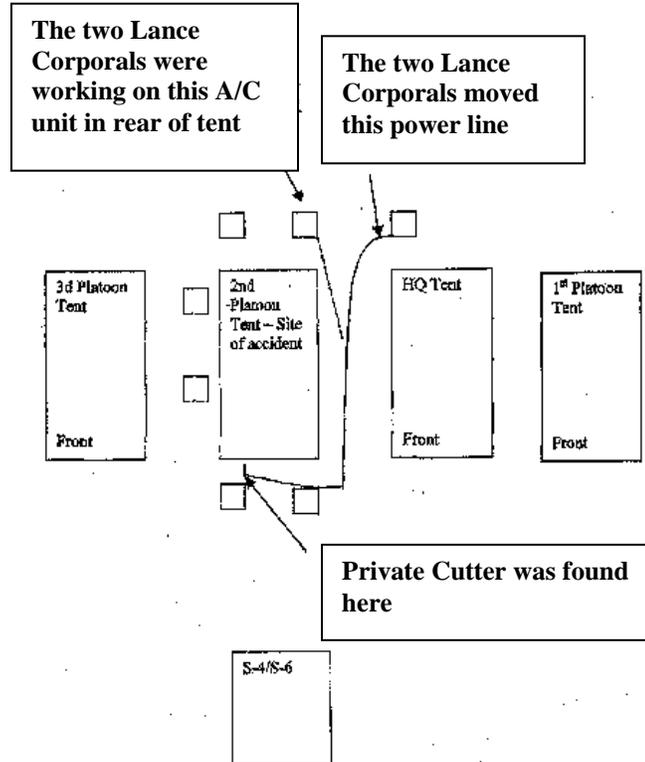
Private First Class Brian K. Cutter was electrocuted while attempting repair on an air conditioner unit at Al-Asad Airbase, Iraq, on May 13, 2004. The site is depicted in the figure below.

**Figure 6. Drawing Depicting Area Where Private Cutter was Electrocuted (From Army Report of Investigation)**

Private First Class Cutter died from electrical shock while using a metal tool and attempting to rewire an air conditioning unit to the breaker box and subpanel/junction box. Resuscitation attempts were unsuccessful.

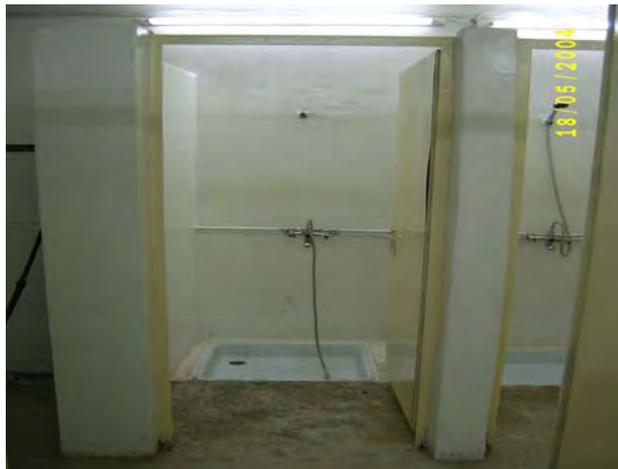
Specialist Marcus O. Nolasco was electrocuted while showering at Forward Operating Base Summerall, Bayji, Iraq, on May 18, 2004. The shower is shown in the figure below.

**Figure 7. Shower Where Specialist Nolasco was Electrocuted (From Army Photographs)**

(Note: An automatic water pump did not maintain water in water heaters, causing a heating element to rupture, resulting in electricity traveling through the metal water lines into the shower.)

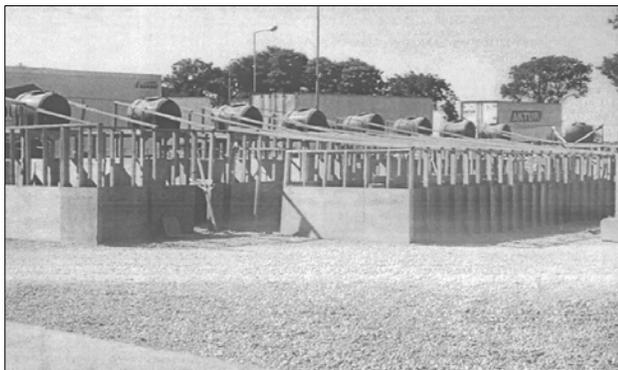
Hospital Corpsman Third Class David A. Cedergren died in a shower facility at Camp Iskandiriyah, Iraq, on September 11, 2004. The shower facility is shown below.

**Figure 8. Shower Area Where Hospital Corpsman Cedergren Was Electrocuted (From Navy Photographs)**

- Outdoor wooden showers with wood slat floors covered in chicken wire mesh. Photographs in the investigative files depict signage at the shower facility warning of "Danger" and "Electric Shock Hazard;" however, the signage is not explained.

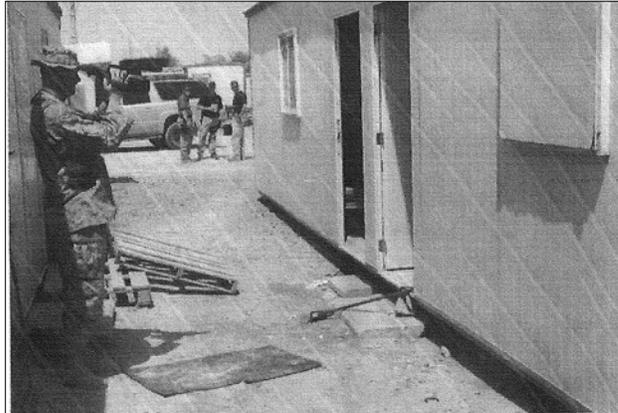
Mr. Sohan Singh was electrocuted while attempting to enter his quarters at Fallujah Surgical, Camp Fallujah, Iraq, on July 19, 2005. The exterior of the quarters are shown in the figure below.

**Figure 9. Quarters Where Mr. Singh Was Electrocuted  
(From Navy Photographs)**

The NCIS investigation determined that Mr. Singh or his roommate improperly installed an air conditioning unit sitting on the floor in Mr. Singh's living quarters. The electrical plug had been removed, and the wires "stripped and stuck" into an electrical receptacle connecting the neutral wire to a live feed, which caused the metal floor, walls and door to become electrified with 217.7 volts. Witness interviews revealed that Mr. Singh had been pouring water on his bare feet to rinse off dust immediately before attempting to open the door to his quarters, at which time he fell to the ground in a convulsion and became unresponsive. The investigation did not disclose any evidence of

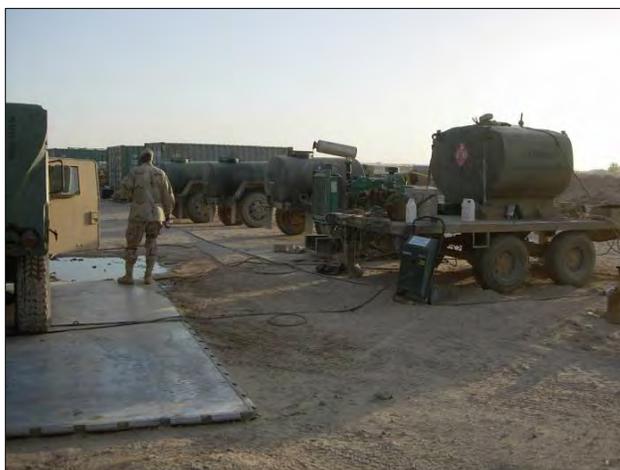
Sergeant Christopher L. Everett was electrocuted while using a power washer at Camp Taqaddum, Iraq, on September 7, 2005. The death scene is shown in the figure below.

**Figure 10. Area Where Sergeant Everett Was Electrocuted (From Army Photographs)**

In early August 2005, a contractor moved an electrical generator to replace an ineffective diesel generator. The new generator provided power for various nearby activities, including a power washer used to clean vehicles. Almost immediately, a military member without electrical or generator training connected the power washer to the new generator. Over the next 2 weeks, people who used the power washer received electrical shocks, including Sergeant Everett and a member of the base's generator repair team. A military maintenance supervisor told the same generator repair team member (who had no formal training in electricity or generator repair) to ground the generator. The team member inserted a grounding rod and connected it to the generator. The power washer continued to shock Service members, and they reported it. On September 7, 2005, Sergeant Everett was electrocuted using the power washer to clean a vehicle.

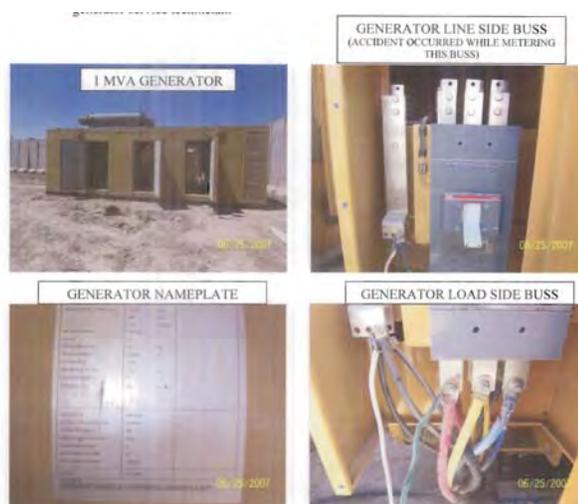
Sergeant Michael J. Montpetit was electrocuted while attempting a generator repair at the Joint Security Station, Forward Operating Base Prosperity, Iraq, on June 22, 2007. The generator is shown in the figure below.

**Figure 11. Generator on Which Sergeant Montpetit was Attempting Repair When Electrocuted (From Army Photographs)**

The accident review board found that Sergeant Montpetit accidentally touched one or more hot bus bars and received an electrical shock through his body, which killed him.

- a) The generator was producing over 400 Volts and pushing about 230 volts to each bus bar.
- b) The burn marks on the back of his hands, indicate that Sergeant Montpetit touched one or more bus bars and was electrocuted as a result. . . .

. . . A week before the accident 15th BSB [Base Support Battalion] fixed an oil leak on the generator's engine. During the visit by the safety team, the electrical engineer noted that the generator was not properly grounded and the Iraqis had placed three feed wires to provide one-phase electricity to some of the buildings on the compound. . . .

As a result, the safety investigation concluded that improper grounding may have contributed to the severity of the injuries. The basic finding, however, is that a trained mechanic accidentally touched one or more bus wires carrying 230-400 volts each with the back of his right hand and was electrocuted while performing maintenance on a

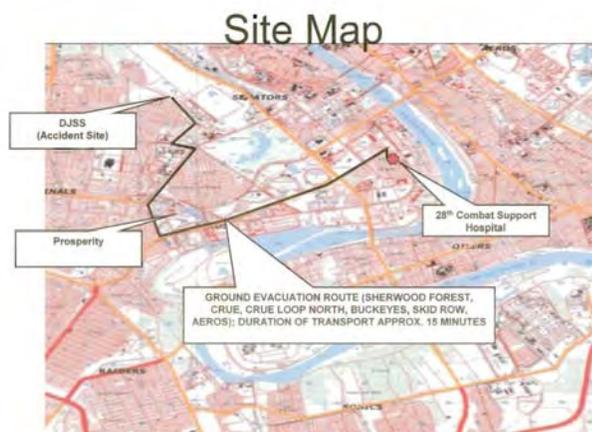
**Figure 12. Site Map Showing Area Where Sergeant Montpetit Was Electrocuted (From Army Report of Investigation)**
