V-22 *Osprey* Hydraulic System
(D-2002-114)

Department of Defense
Office of the Inspector General

SUBJECT: Evaluation Report on V-22 *Osprey* Hydraulic System
(Report No. D-2002-114)

Report No. D-2002-114

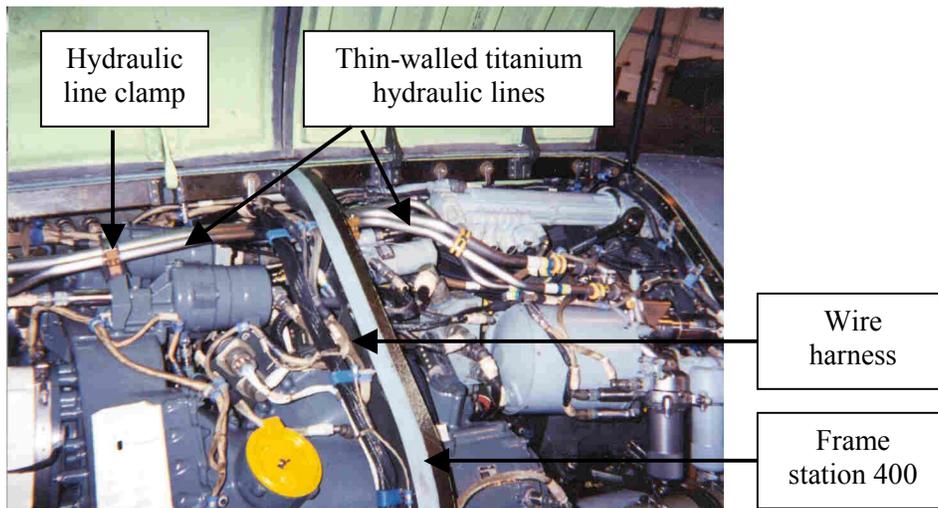
Figure 2. Outboard Right Nacelle of an LRIP Aircraft

The V-22 nacelles, located at the end of each wing, house the aircraft's engine and rotor system. The nacelles are densely populated with engine and rotor system components, including actuators, wire harnesses, and lines (including thin-walled titanium hydraulic lines¹²) that are intricately routed and in close proximity to one another. Because the hydraulic system is designed to operate at 5,000 pounds of pressure per square inch, it provides the opportunity to use smaller actuators and allows for a more compact packing of the nacelle. To achieve a lower aircraft weight, thin-walled titanium hydraulic lines are used in the nacelles and other locations throughout the V-22. Figure 2 illustrates the compact and heavily populated environment of the V-22 nacelles and identifies the frame station 400 as well as one of the many hydraulic line clamps, thin-walled titanium hydraulic lines, and wire harnesses within the V-22 nacelles.

VMMT-204 maintenance personnel, the Line Clearance IPT, and the Panel indicated that the hydraulic system problems experienced by the V-22 Program were primarily caused by a compact nacelle design, which made it difficult to minimize the impact of vibration, and a manufacturing variance referred to as “artisan latitude.” Vibration and artisan latitude can result in hydraulic line chafing that degrades the reliability of the hydraulic system.
