INSPECTOR GENERAL

Department of Defense

JULY 18, 2013

Compliance with Electrical and Fire Protection Standards of U.S. Controlled and Occupied Facilities in Afghanistan

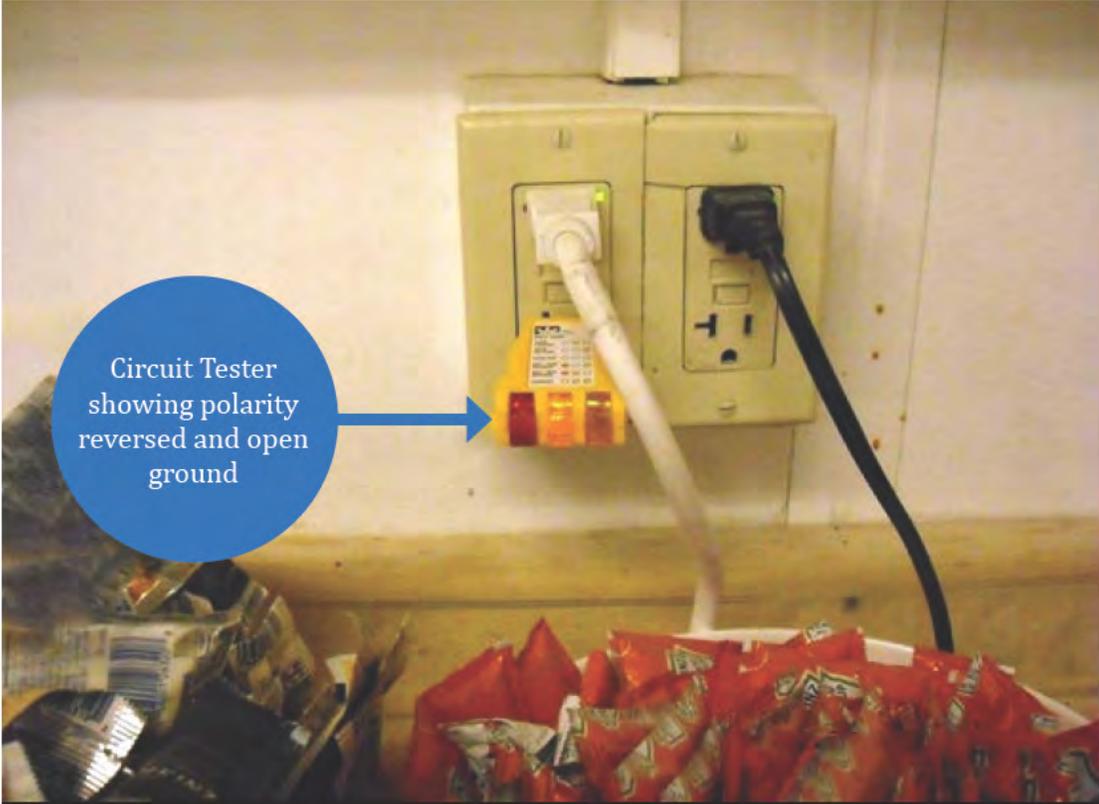
- In Building 518, reverse polarity and no grounding of kitchen receptacles: (Finding KAF-EL-120426-026)
- In Building 518, main electrical panel wires are not color-coded to any standard: (Finding KAF-EL-120426-025)
- In Building 156 “Old Kandahar Hotel,” live power cables placed directly on roof top: (Finding KAF-EL-120426-084)
- In Building 156 “Old Kandahar Hotel,” there are unprotected wires used throughout the living quarters: (Finding KAF-EL-120426-047)
- In Building RLB7B, living quarters are unsafe for occupancy due to severe wiring issues: (Finding KAF-EL-120426-097)

KAF-EL-120426-026
Figure 1. Reverse Polarity and No Grounding - Chaplain's Office Building Kitchen Area

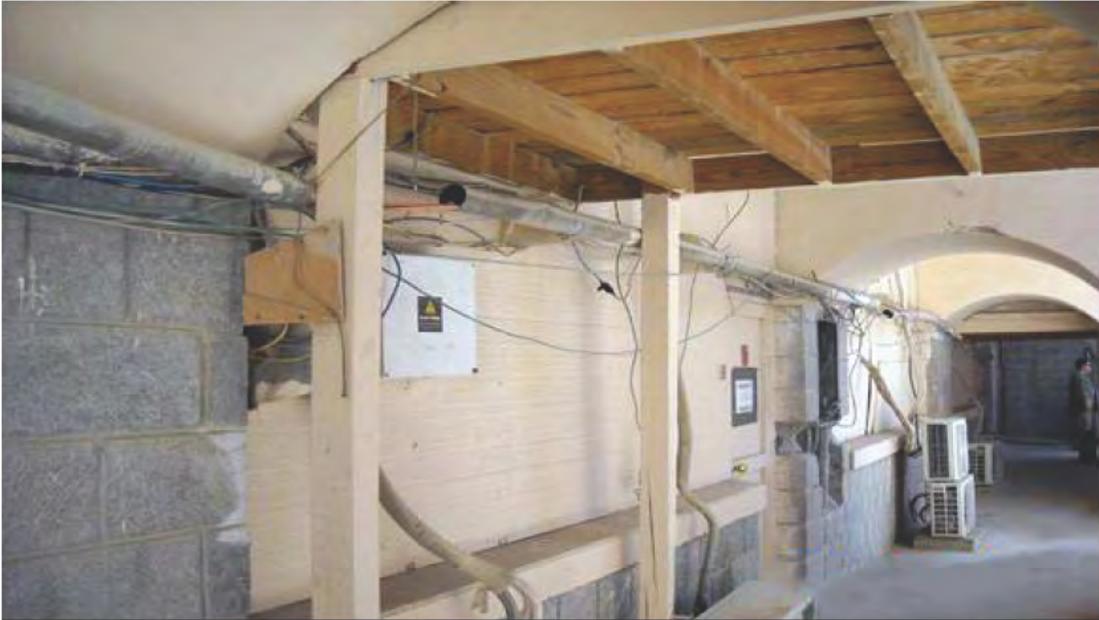
2. **Misuse of plastic-sheathed cables:** Multiple cases of indoor-rated, plastic-sheathed cables used in damp outdoor locations, unsupported and unprotected by conduit and raceways (Figures 2, 3, and 4). Improperly mounted cables and breaks in raceways increases the risk of abrasion and breaks in conductors, which could cause fire, electrical shock, and/or electrocution.

KAF-EL-120426-055
Figure 2. Noncontiguous Raceway in Outdoor Location

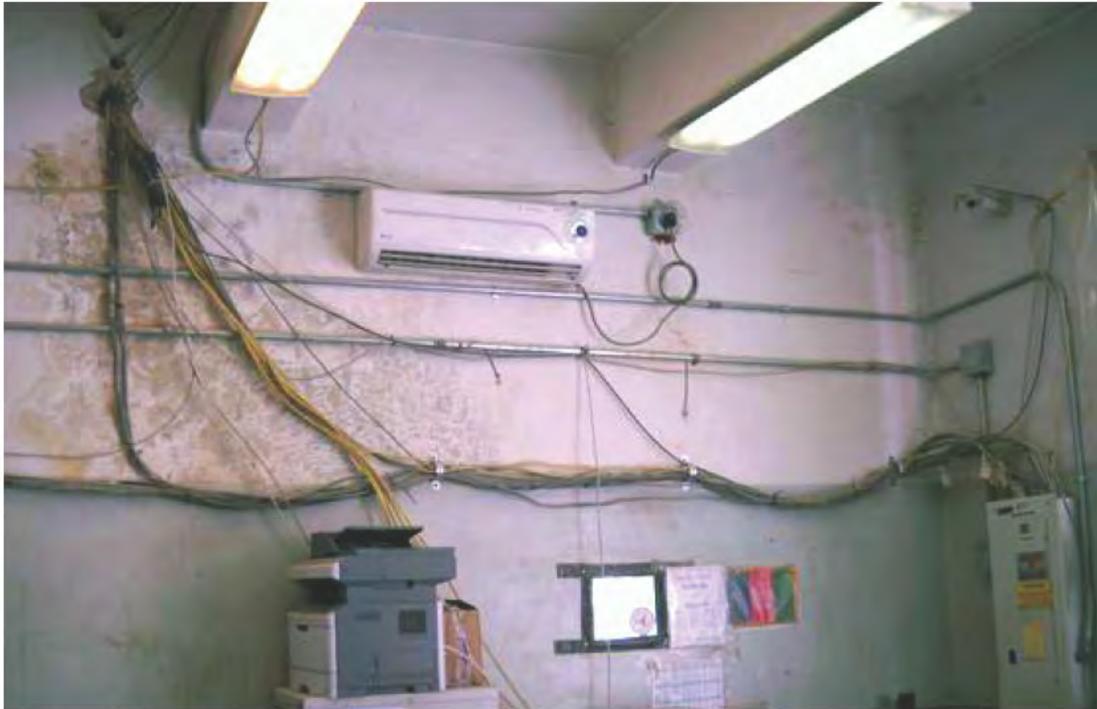
BAF-EL-120709-169
Figure 3. Unsecured and Unprotected Cables – Main Post Exchange

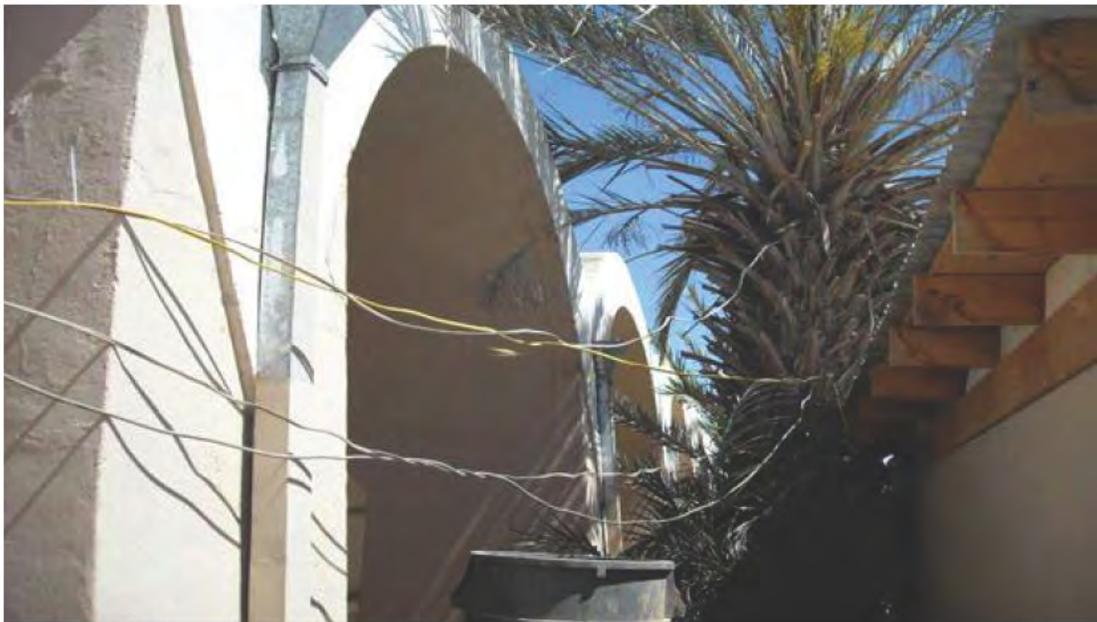
KAF-EL-120426-056B
Figure 4. Outdoor Hazardous Service Drops to Living Quarters

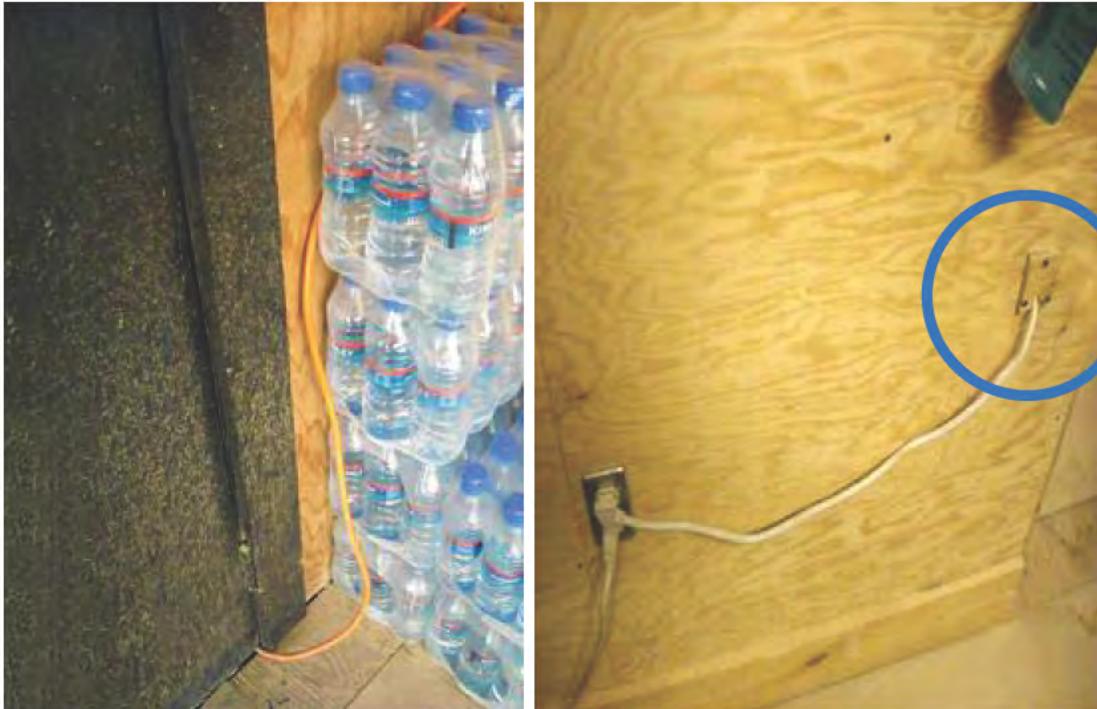
was significant. Extension cords used under these conditions are subject to damage and abrasion (figure 5). The use of an extension cord instead of fixed wiring creates the possibility of fire, electrical shock, and/or electrocution due to unprotected live conductors and overloading of circuitry.

KAF-EL-120426-072 (left) KAF-EL-120426-087 (right)
Figure 5. Extension Cords Used as Permanent Wiring Run Through Doorways and Walls – Office Building

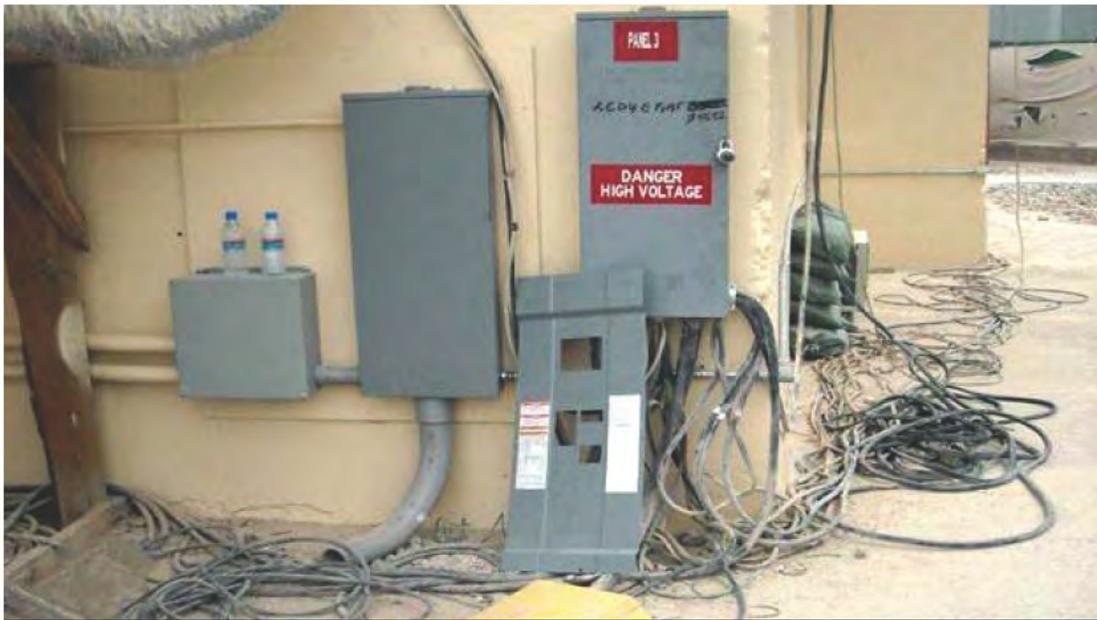
4. **Hazardous electrical service to facilities:** Electrical wires supported by rooftops, many cases of incomplete or damaged electrical panels, and electrical panels that are missing front covers and other covers for openings (Figures 6, 7, 8 and 9). Power lines draped over the top of buildings and structures present a high risk for fire and electrocution. Energized panel enclosures with front covers that do not fit properly expose energized wires, increasing the risk of electrocution to personnel accessing the circuit breakers. Also, damaged electrical panels present the possibility of other unseen internal damage and could result in ground faults/arc flash and potential fire, electrical shock, and/or electrocution.

KAF-EL-120426-075
Figure 6. Hazardous Workmanship

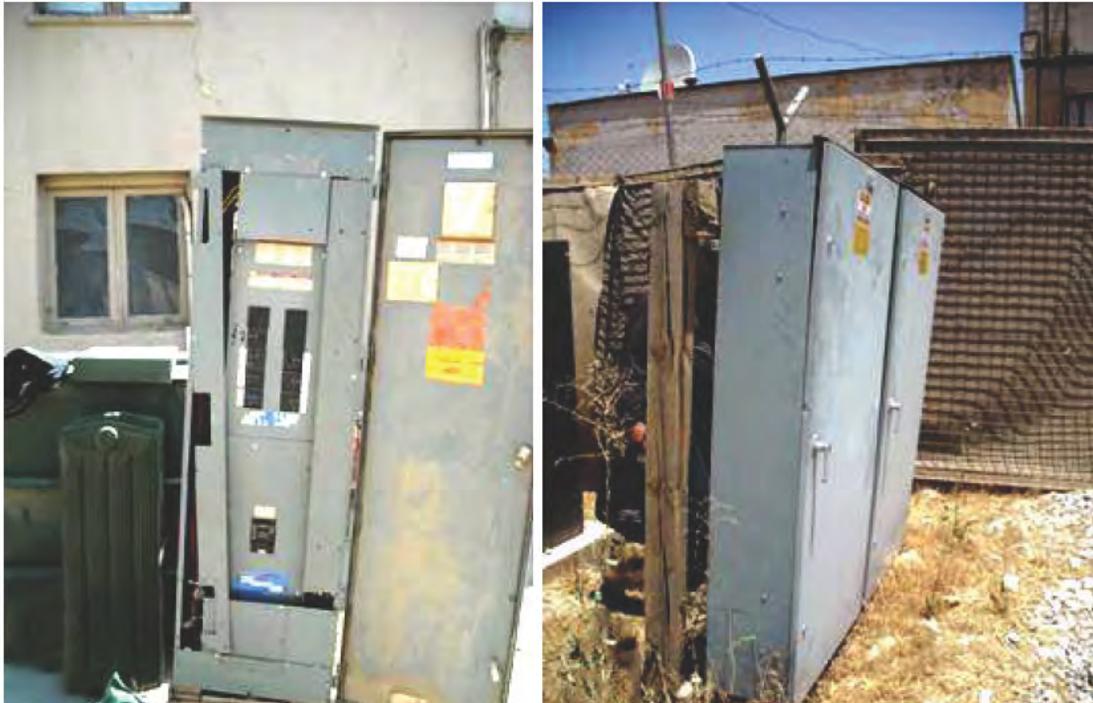
BAF-EL-120709-017 (left) BAF-EL-120709-063 (right)
Figure 7. Damaged and Hazardous Electrical Panels

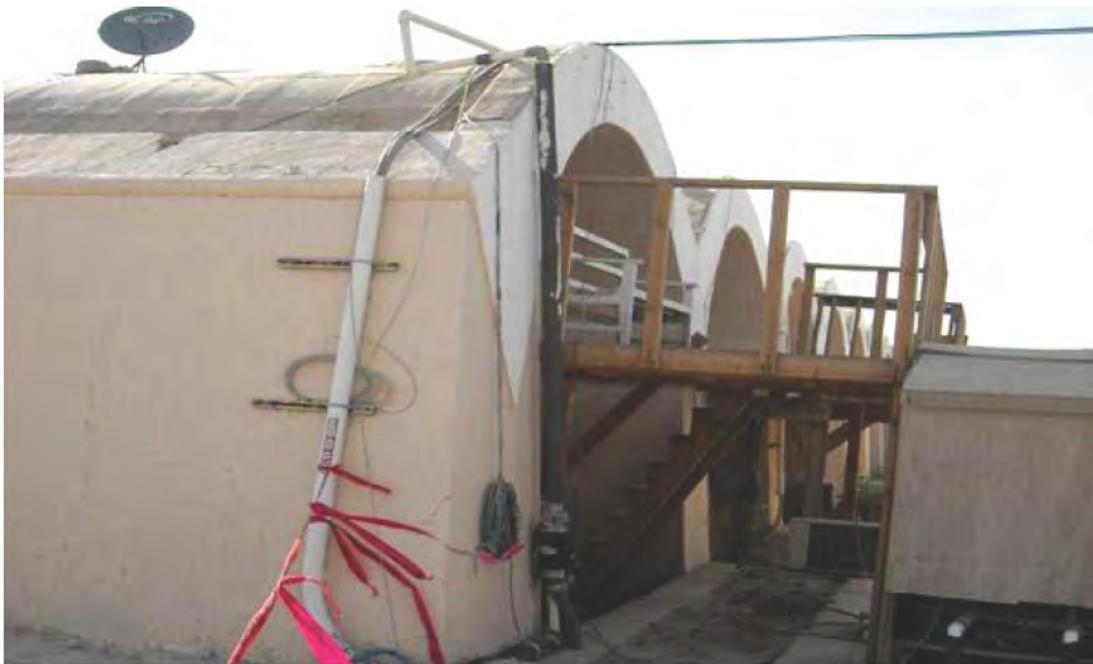
KAF-EL-120426-084
Figure 8. Power Lines Run Across Roof of Living Quarters

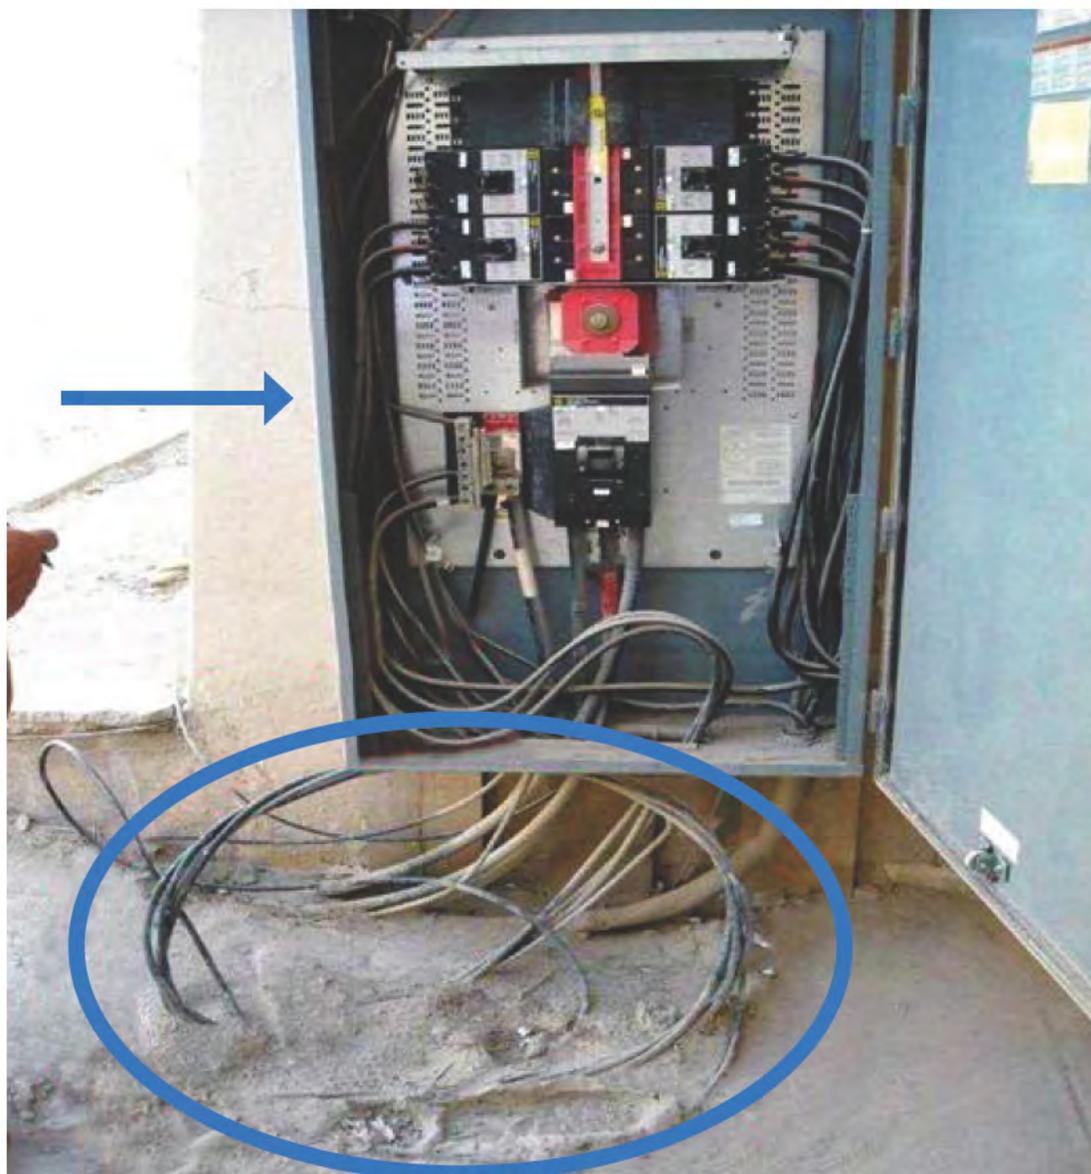
KAF-EL-120426-057

Figure 9. Unprotected Cables Buried in Concrete (Circled) and Missing Front Panel Covers

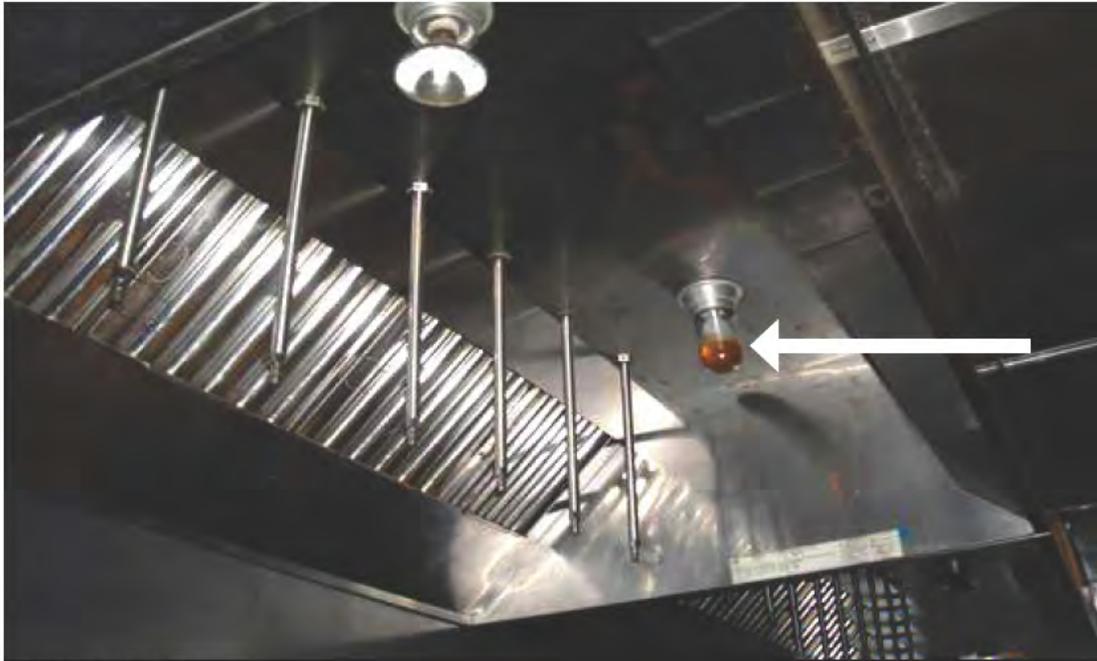
BAF-FP-120709-333
Figure 12. Nonfunctional Kitchen Fume Hood Fire Suppression Systems
(Note Flammable Grease in Light Fixture)

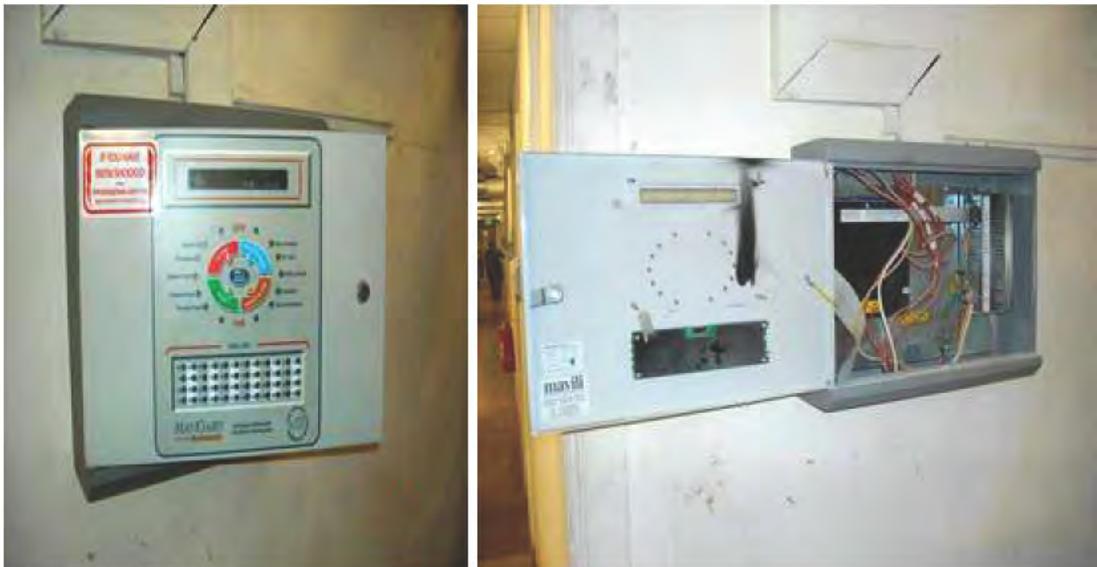
BAF-FP-120709-244
Figure 13. Inoperable Fire Alarm Systems In Living Quarters
Closed and Opened - Burned Out with Internal Control Panel Removed

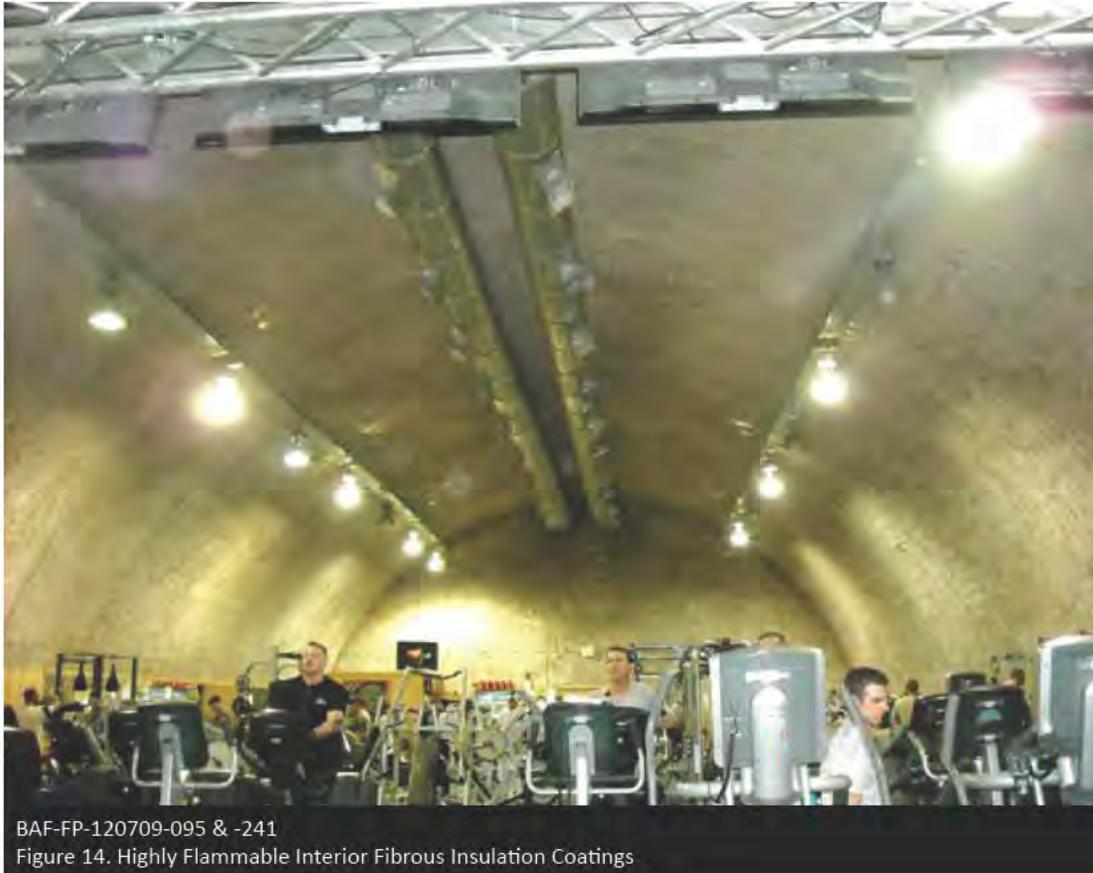
BAF-FP-120709-095 & -241

5. **Construction-passive protection:** Lack of firewalls in sleeping areas, inadequate exit protection, and combustible materials (Figure 14). The systemic use of combustible materials in sleeping areas creates an increased risk of fire, which could lead to the loss of life and mission-critical assets.

Figure 14. Highly Flammable Interior Fibrous Insulation Coatings
