INSPECTOR GENERAL

The Army Did Not Properly Account For and Manage Force Provider Equipment in Afghanistan

SUBJECT: The Army Did Not Properly Account For and Manage Force Provider Equipment
in Afghanistan (DODIG-2014-098)

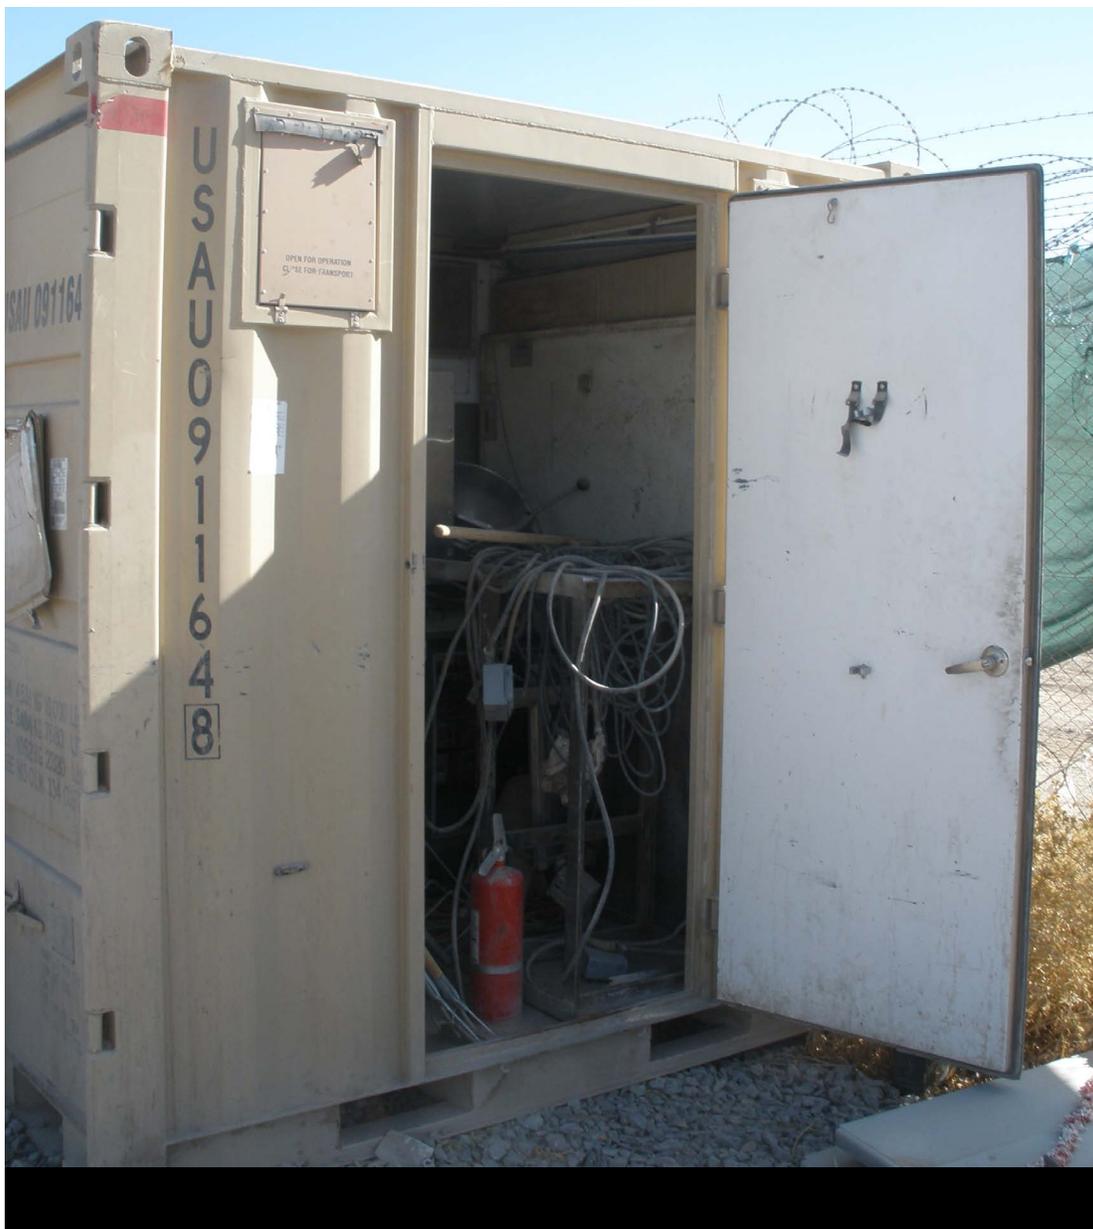
Further, without proper accountability, the risk of units abandoning equipment significantly increases. For example, we identified two instances of abandoned FP equipment at two bases in Afghanistan where we conducted fieldwork. At Bagram Airfield, we identified approximately \$183,860 worth of FP equipment that a unit had abandoned in a yard for at least 7 months. At Kandahar Airfield, we identified at least \$104,000 worth of FP equipment in an abandoned yard that had been left unsecured and exposed to the elements for an unknown amount of time. Figure 4 provides an example of discarded FP inventory we observed at the abandoned yard at Kandahar.

In addition to the FP equipment at Kandahar, we identified secret- and controlled-inventory items in open containers and triwalls in the same unsecured yard. We communicated our observations to retrosort yard officials at Kandahar and Regional Command South personnel for immediate attention. The Chief of Staff Regional Command South immediately secured the secret- and controlled-inventory items and opened a security investigation to determine how the items were abandoned

at the lot. The Regional Command South investigation determined that the yard contained a total in excess of 1,874 items, valued at over \$2.2 million, including 28 sensitive items valued over \$380,000 and 2 high-dollar items valued over \$442,000. The investigation concluded that due to systemic failures in the property accountability procedures, the investigators could not determine with definitive accuracy any individual that could be held liable for the abandoned items.
